Smoke and Dye Testing Summary

High Level Sewershed

Run Summary

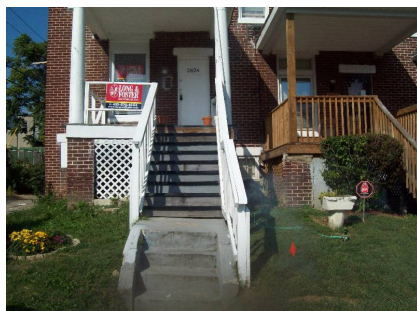
Picture \S1028-108-OB01-P01.jpg

Source Cleanout

Location Yard - front

Comments Smoke from cleanout in front yard. 2824 Belmont Ave.

Comments Front of house, 2824 Belmont Ave.
